Implications of Sea Level Rise on Coastal Pavement Infrastructure for the Funafuti Airport Runway (Tuvalu)

**Henning TFP , Freer, C., Mangan, D. & Ransley, C
August 2017**

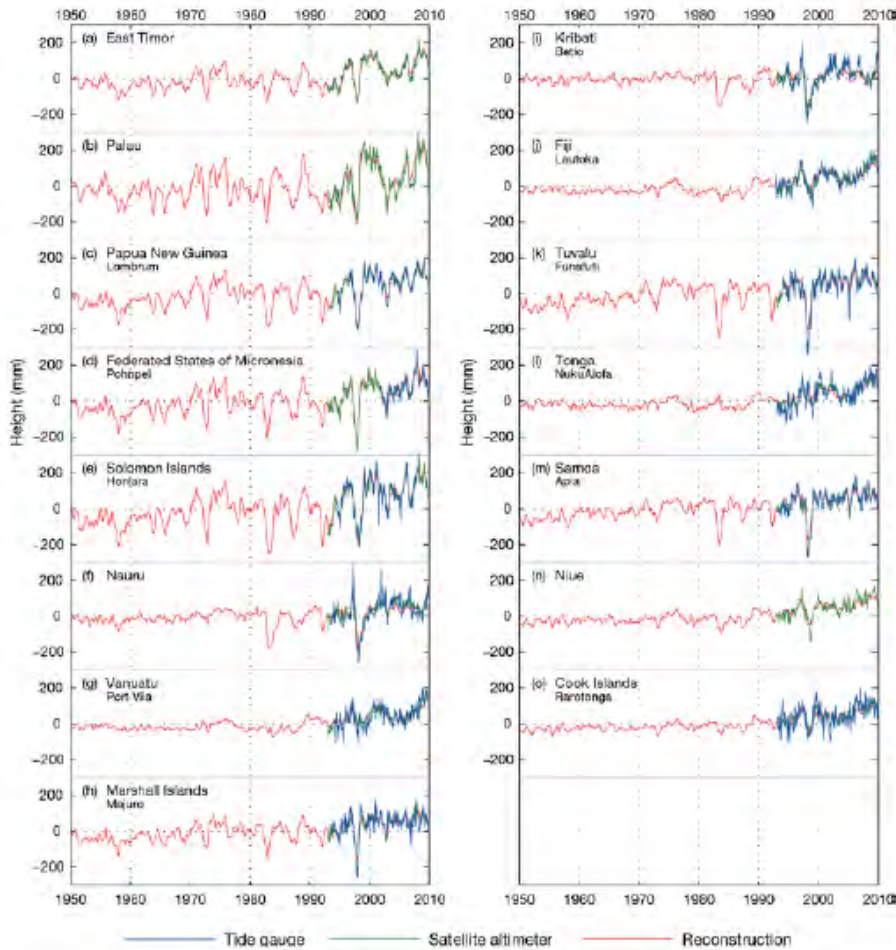
Figure 2.1: Time series of monthly tide gauge data (blue) with satellite altimeter data (green) and reconstructed sea levels (red) (ABM and CSIRO-Vol 1, 2011)

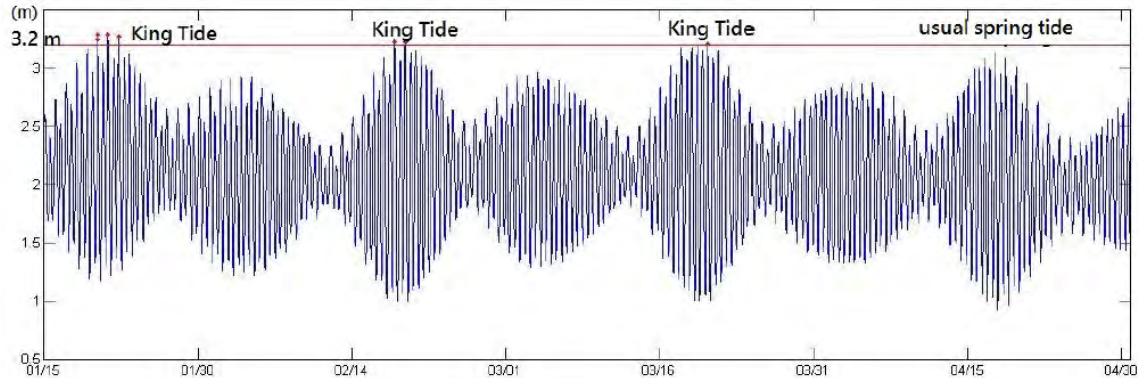
Figure 2.2: Tidal Patterns During 2011 (Lin et al, 2014)

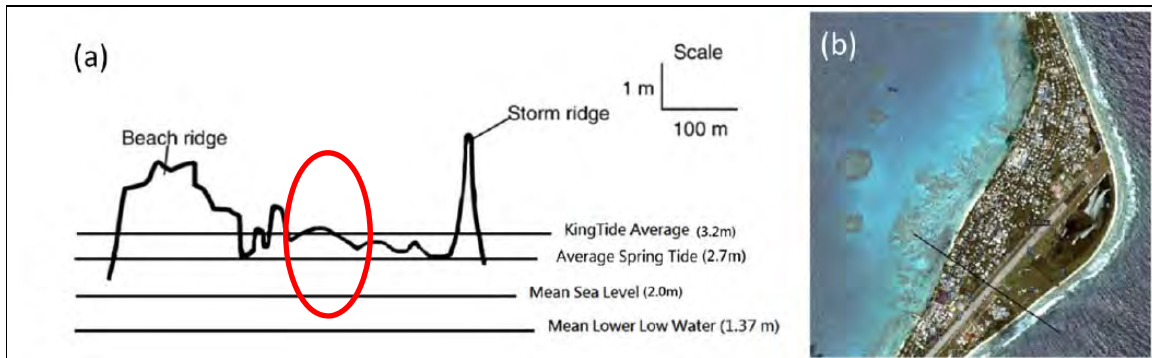
Figure 2.3: A Profile of Funafuti Indicating Tidal Levels and how it Relates to the Runway (Lin et al., 2014)

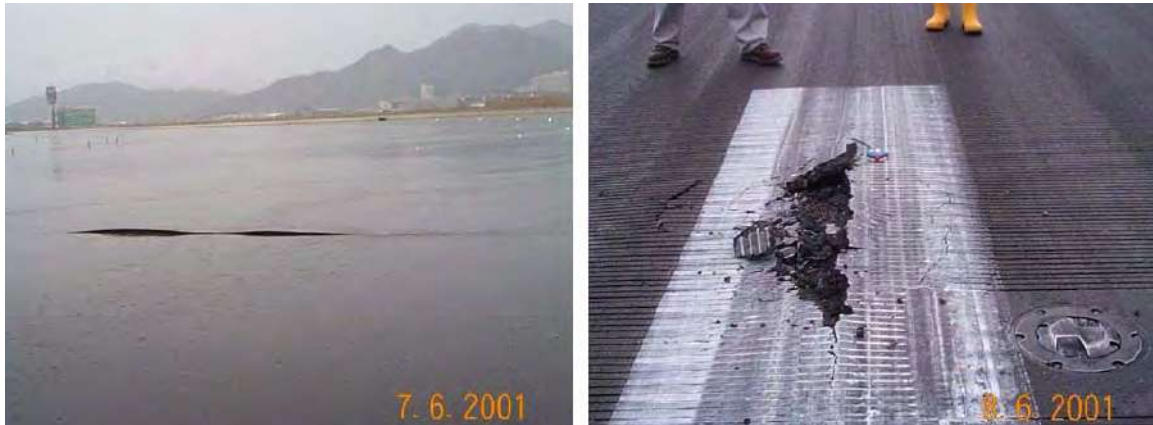
Heaving of the runway surface was observed almost directly following the opening of the runway (some as high as 400 mm and a diameter of up to approximately 10m). The heaving was observed following prolonged rain spells. One year following the construction the heaving progressed into secondary defects such as delamination, cracking and potholes. Figure 2.6 illustrates some of the secondary defects.

Figure 2.6: Damage on the Hong Kong Runway (Leung et al., 2007)

Investigations yielded potential causes of the damage to include:

- *After review of the combined tide and rainfall record, followed by site measurement and laboratory soil testing, the investigation concluded that the pavement heaving was caused by the build-up of air pressure underneath the pavement due to the rising tide and blockage of free air flow in the saturated capping sand layer. Under the dry weather, a*

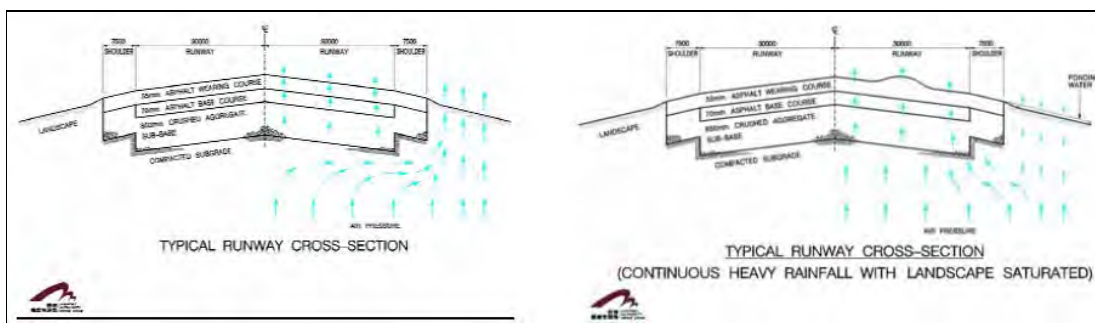
- The wetting of the surface of the asphalt also reduced the air permeability of the asphalt pavement and its ability to dissipate air pressure. The rapidly rising tide pressurised the trapped air in the air voids in the granular layer beneath the pavement and caused the heaving.”

Figure 2.7: Illustration of Water and Vapour Movement through the Pavement (Leung et al., 2007)

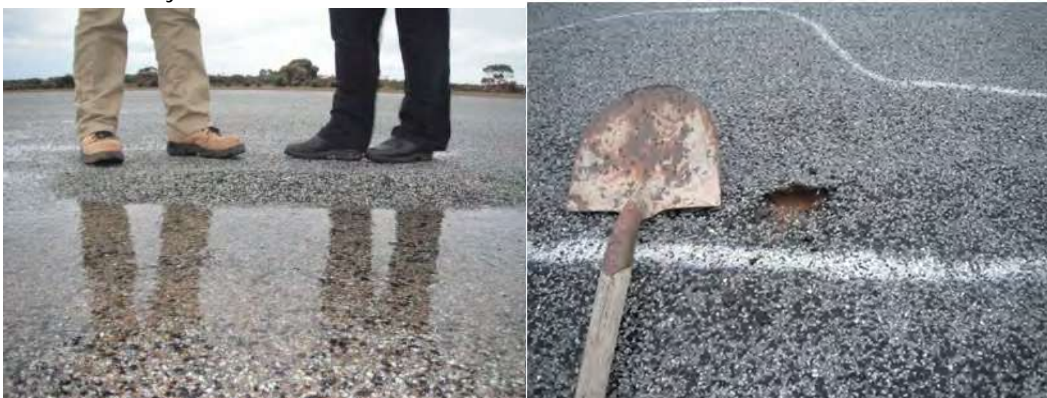
From the evidence provided it was noted that the seal was constructed to provide a water-tight surface. In the presence of rising ground water, there was a build-up of vapour pressure that lifted the seal up to form blister patterns similar to that of the Funafuti runway (Refer to Figure 2.10). The same defects were also observed on the Barrow Island runway, but it was a limited occurrence following a cyclone event². A fundamental difference between these two runways and Funafuti was that both the Australian are inland airfields (no tidal effects) and the blistering issue has only occurred following significant rainfall events. Also, the only defect observed was the blistering with no other secondary defects.

Figure 2.10: Blistering on the Seal at Albany City Airport (Paul G Robertson & Associates, 2011))

Note: The same large seal "blister" after the seal surface had been broken and lifted with the adjacent shovel to release any gas or vapour. The gravel pavement surface was dry before the seal was opened.

The blistering issue at Barrow Island was resolved by overlaying the runway with a 50mm asphalt surface. The runway at Albany City was repaired by using a screwdriver to puncture the surface to

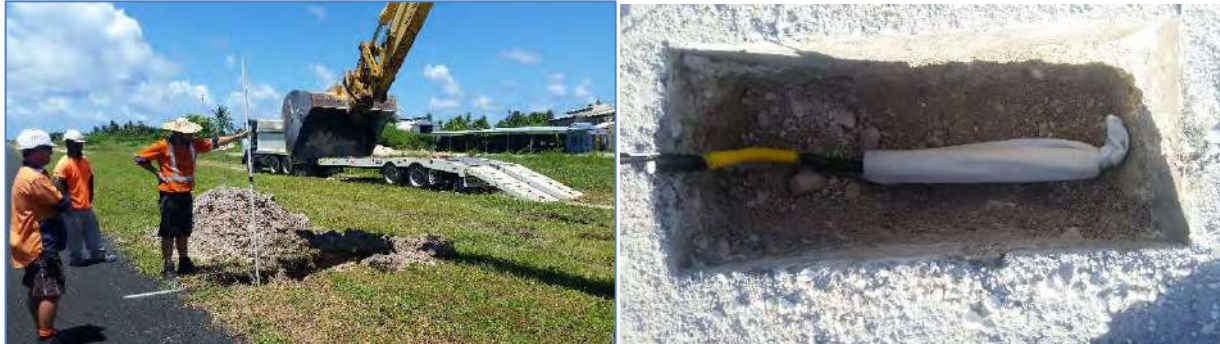
- Excavation of two test pits adjacent to the side of the runway to a depth of 1.4m
- Installation of a single 32mm dia. PVC standpipe within each pit (BH1-2) to a depth of 1.4m bgl.
- Installation of levelloggers within the PVC Standpipes to monitor groundwater levels.
- Coring four additional test excavations through the airport runway and taxi apron to a depth of 0.2m.
- Installation of a vapour pressure logger within each cored hole with a direct read cable to read the information outside the runway apron to record vapour pressures under the airport pavement.
- Reinstatement of the runway pavement with rapid set, high strength grout and sealant.
- Installation of a barrologger within the airport compound to record barometric pressure at the site.

Figure 3.1: -Installation of Piezometer in BH1 and Installation of vapour pressure logger within the shallow pit.

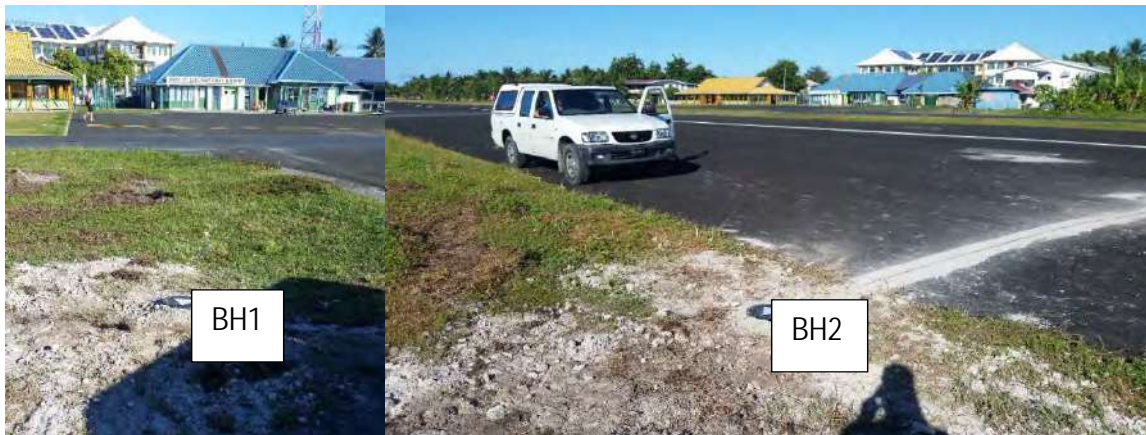
The ground conditions are summarised on the attached site investigation summary in Appendix B. Levellogger 1 was installed on the side of the runway adjacent to the terminal. Levellogger 2 is located on the opposite side of the runway, opposite the Ministry of Works building.

Figure 4-Levellogger installations near the terminal building (6 March 2017)

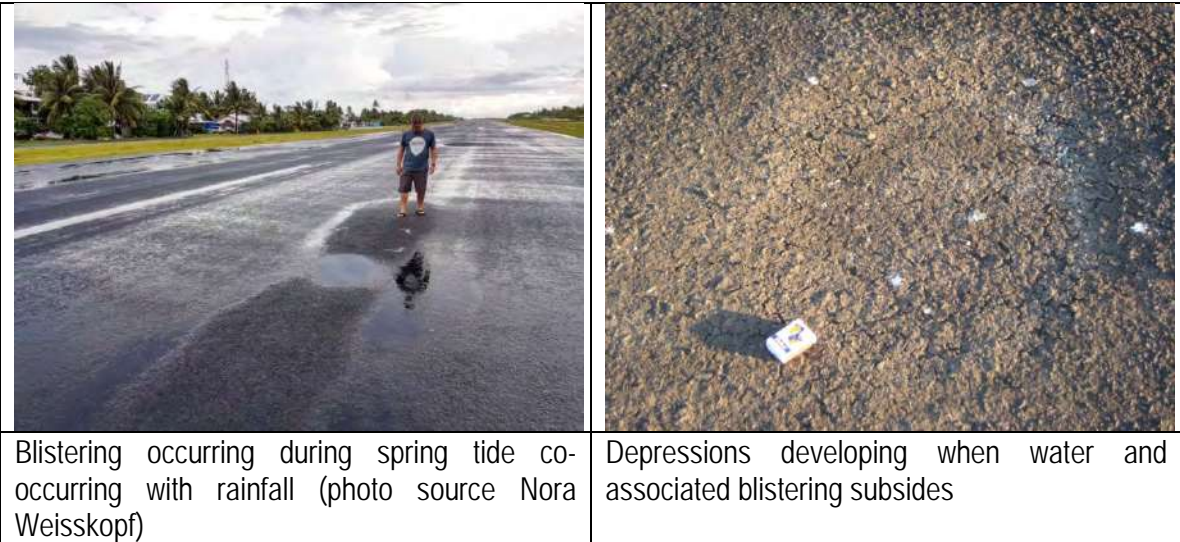
- Where blistering has occurred, permanent delamination damage often occurs in the basecourse surface leading to depressions on the surface of the runway (Figure 4.1);

Figure 4.1 Blistering Mechanism on the Funafuti Runway

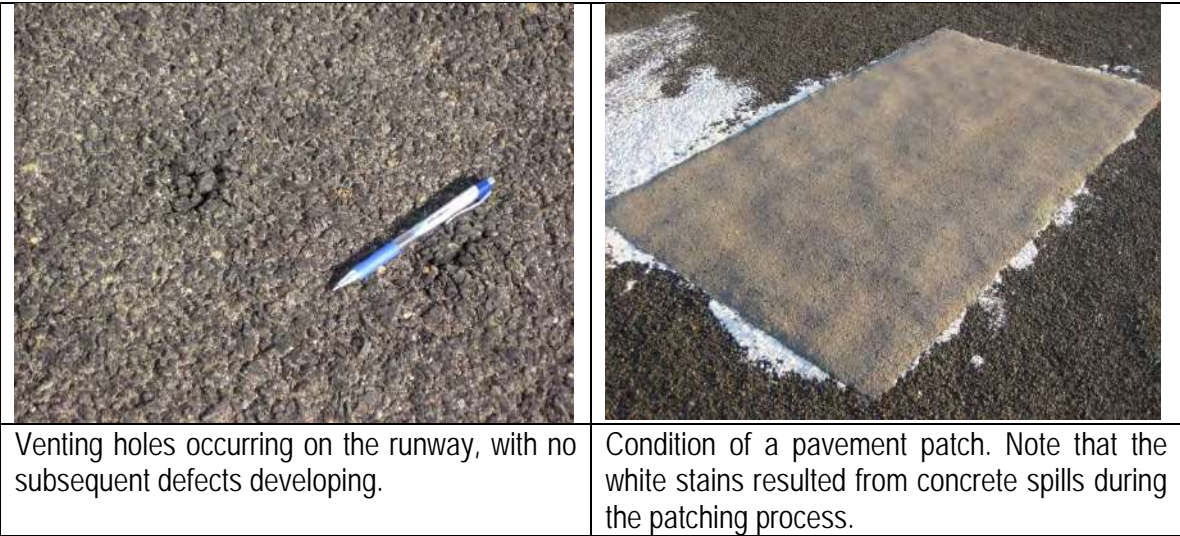
- There are venting holes that have developed in certain areas of the runway, these vents seem to be effective in alleviating the pressure below the runway surface; and,

- The pothole patches that have been constructed through the Funafuti Works Department seem to be effective in addressing the defects. There is, however, evidence of new venting issues developing within the same vicinity of the patches signalling an on-going issue.

Figure 4.2: Surface Venting Holes and Patching of the Runway

The visual inspections concluded that there is an on-going issue and need to vent the pressure build-up beneath the runway surface. Attempts to seal this off would be futile as the entire substructure is pervious and water levels are rising above surface level thus resulting in an inevitable pressure build-up. Remedial options need to include some degree of sub-surface venting.

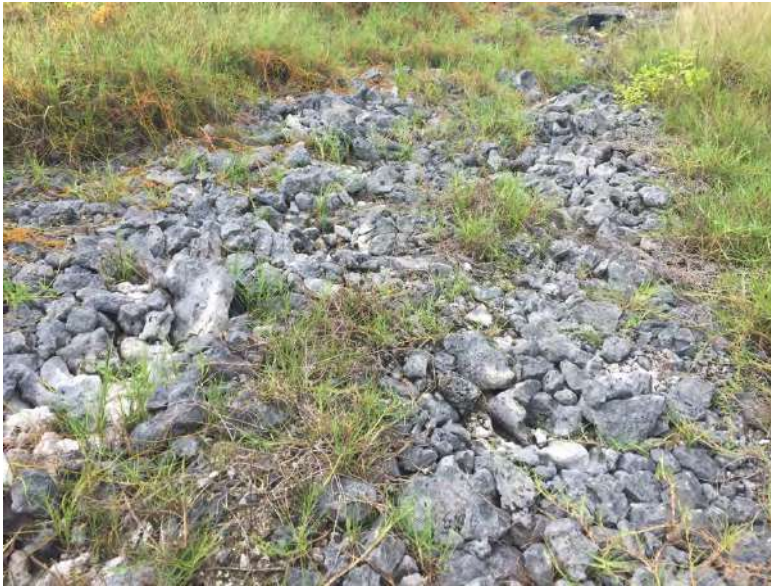
Figure 4.3: Evidence of Venting Paths Through coral sub-grade Formation (Source Glenn Fawcett)

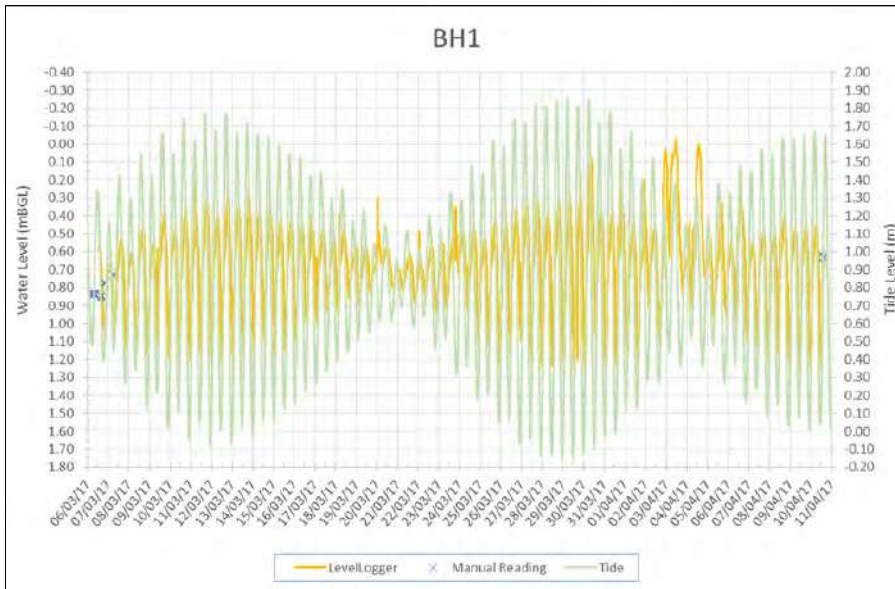
The water level logger at Site 1 recorded water level fluctuations which mimic the tidal fluctuations albeit on an attenuated basis. The tidal fluctuations generally range from 0.7m to 2.1m on an about fortnightly cycle whereas the water level range varied between 0.2m and 1.1m (refer to Figure 4.4). The high rainfall event at the beginning of April caused a 0.3 m rise in the groundwater level which was superimposed on the tidal fluctuation resulting in the water level reaching ground surface over the period of April 3rd and 4th.

Figure 4.4: Water Table and Tidal Level Measurements (Levellogger Site 1)

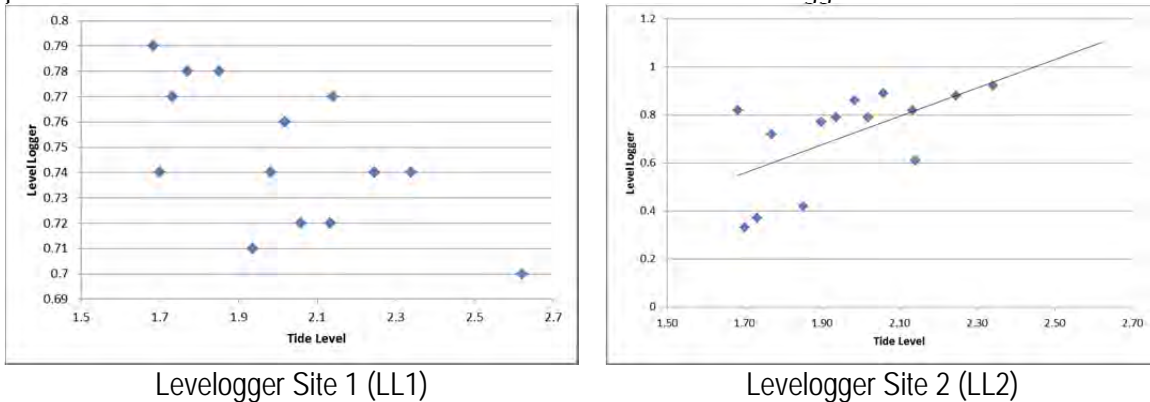
During the time of this report, insufficient data was received from the second borehole, with the levellogger being replaced on 14th April. However, it is expected to observe better correlation with the tidal fluctuations from this borehole. Figure 4.5 illustrates the difference in water table from the two boreholes during the manual measurements on site during the initial installation. Better potential correlation with the tidal fluctuations is evident for the levellogger at site 2.

Figure 4.5 Comparing Manual Readings Water Level from the two Boreholes

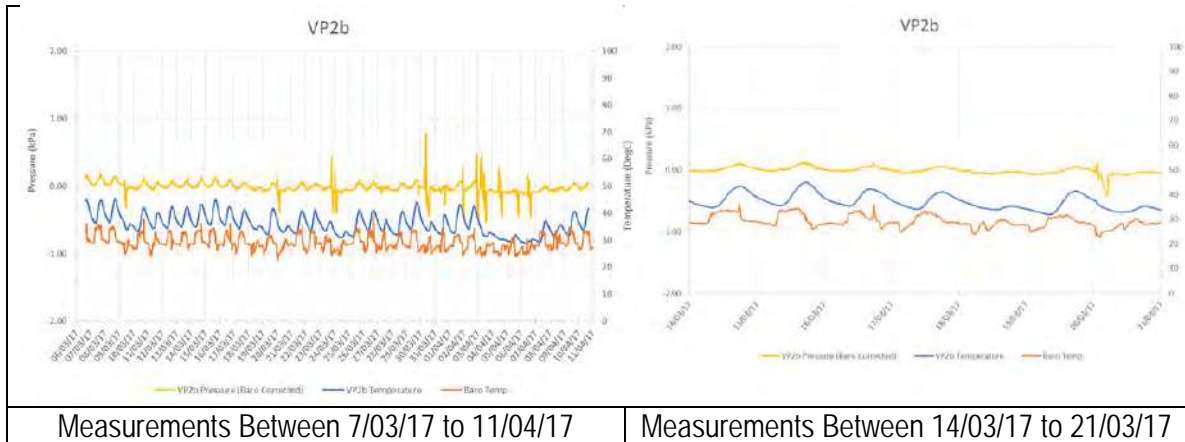
Superimposed on these short-term cycles there appears to be a longer term cycle which repeats approximately monthly (during spring tides) with an amplitude of 0.6 kPa.

Measurements Between 7/03/17 to 11/04/17 Measurements Between 14/03/17 to 21/03/17
 Figure 4.6: Comparing Vapour Pressure with Temperature Measurements at Vapour Site 2b

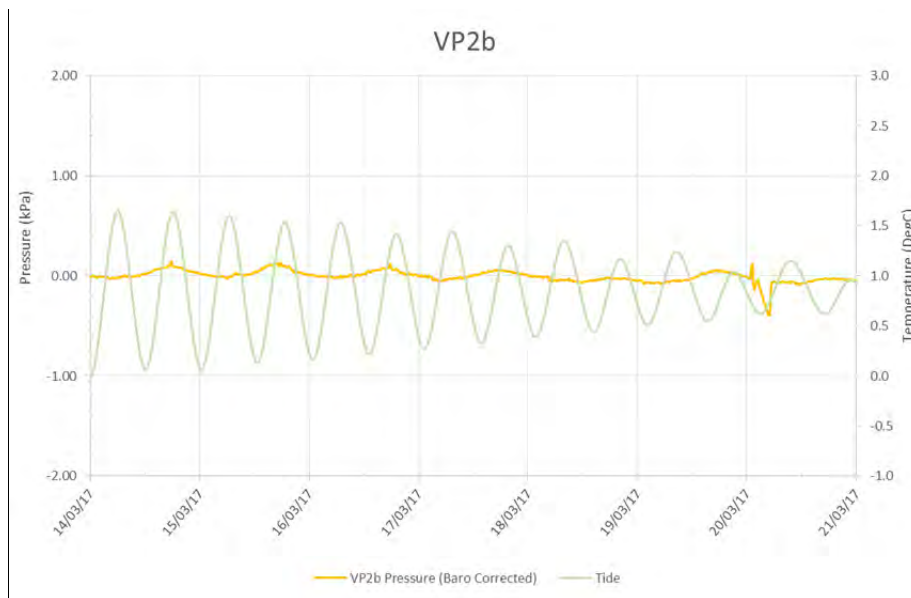
Figure 4.7: Comparing Vapour Pressure Measurements with Tidal Fluctuations (Site 2b)

When the gauge pressure is corrected for the prevailing atmospheric pressure, the longer term cycle disappears which would indicate that the vapour pressure merely reflects variation in the atmospheric pressure. A longer term record may indicate the repeatability of this cycle. The corrected pressure records also show that gauge pressure does not exceed atmospheric pressure by more than 0.2 kPa except for "spikes" which appear on a random pattern.

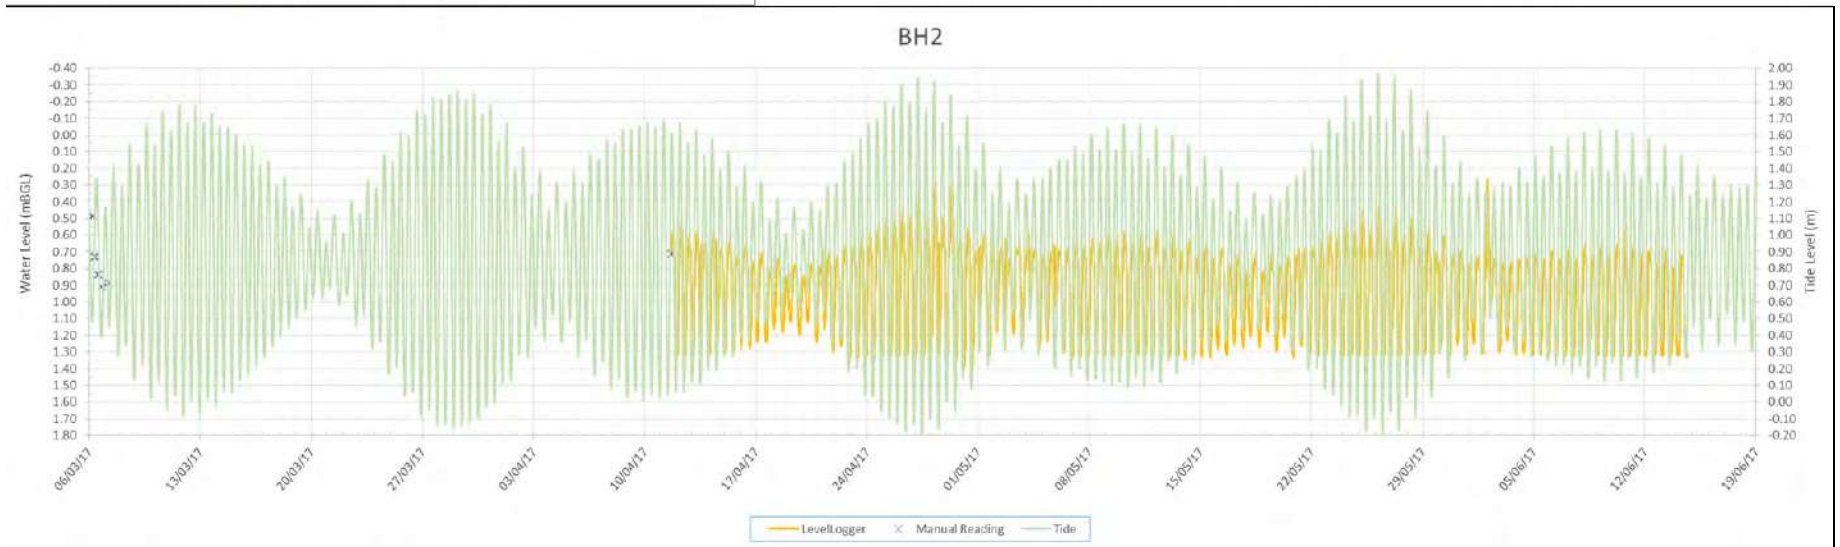
Levellogger 2:

Note: Instrument malfunctioned during the first month

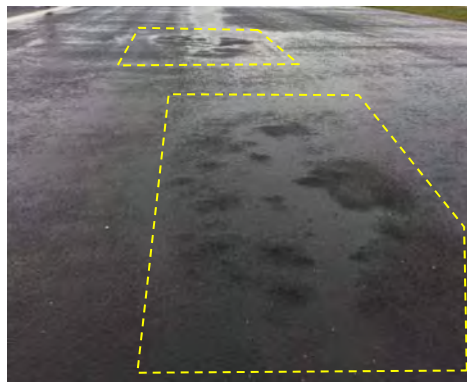
Venting areas can be identified by small bumps in the basecourse. This is most obvious after rain, in evening light or during venting

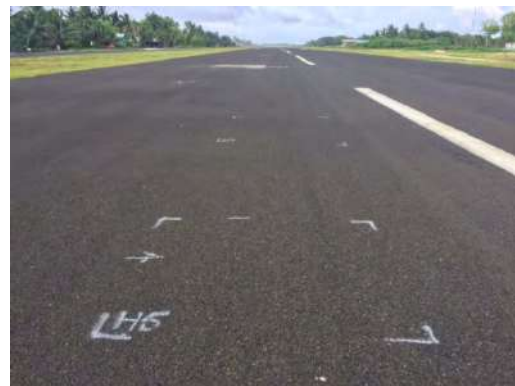
Pavement venting areas marked up. Patches were also inventoried.

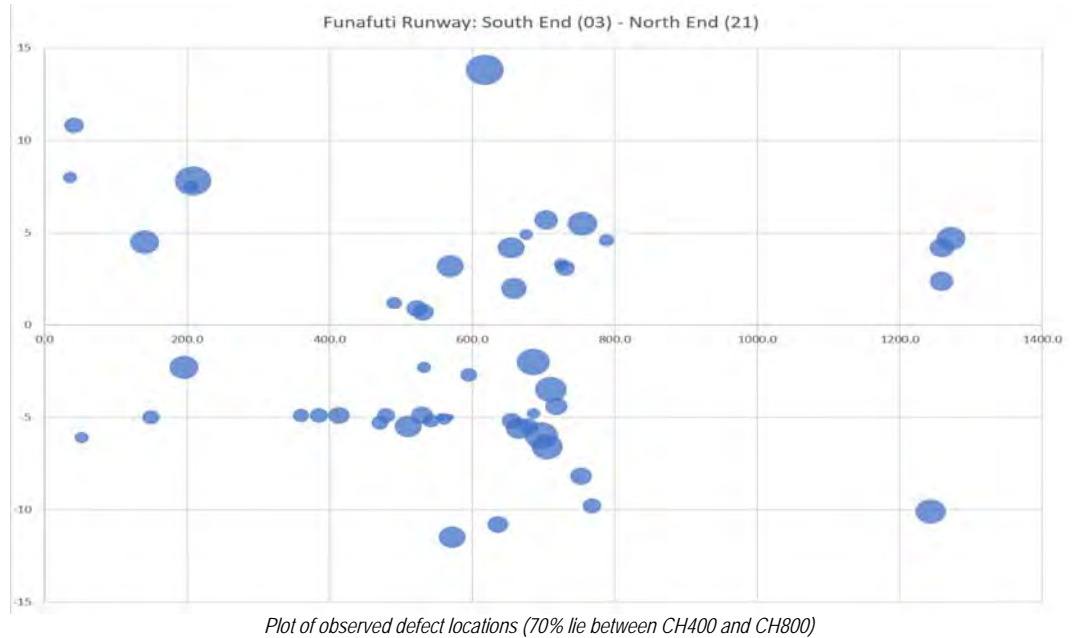
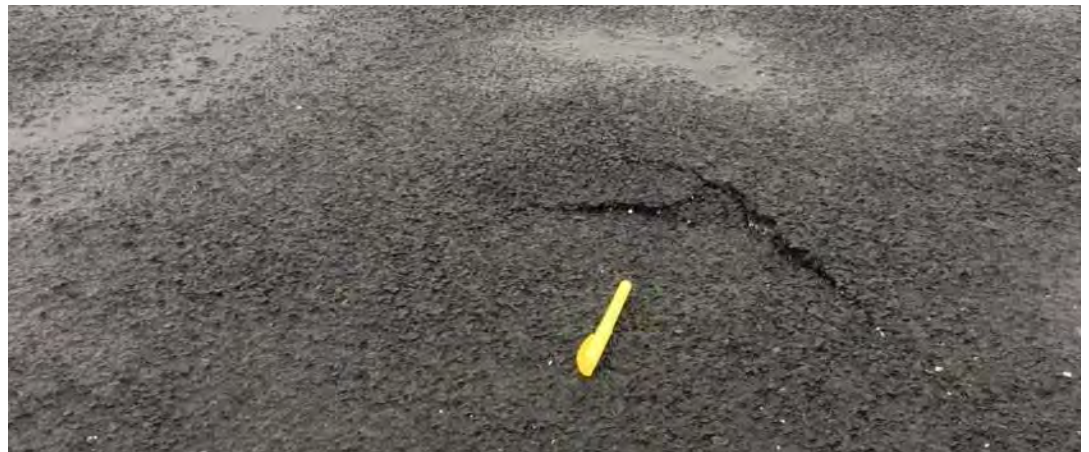
Two areas have suffered a “rupture” of the surface due to the venting movement.

Observed rupture of 3-coat bitumen surface during significant venting (Condition Score = 2)

With hot weather, these ruptures have since settled a little but will require close monitoring and a digout repair over the next 4-6 weeks. Digouts may be smaller (or larger) than the marked monitoring areas and the final extent should be determined as the surface is cut and removed.

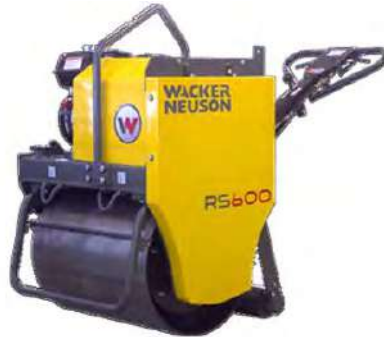
Steel drum roller (ex.Reeves)

Urgent, *temporary patching of small areas* (<0.5m²) could be done by saw cutting and removing the bitumen surface(s) to 50mm and compacting coldmix in 25mm layers. A hand tamper could be used for the lower level with a plate compactor to finish the top level.

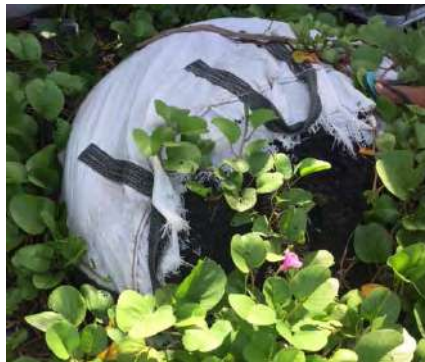
Part bag of cold mix AC "stored" in CAA compound

Note that there is a part bag of coldmix (approx. 0.75T) left over from earlier pavement patching in CAA's compound. This mix was still active when inspected and could be livened up further with a small amount of kerosene (amount to be determined through test rolling/compaction).

Based on the assumption that areas given a condition score of 1 or 2 are likely to fail over the next 6-18 months then material orders should be sufficient to repair around 100m² of pavement. At 50mm deep this **would eventually require around 12T**. Polymer modified cold mix AC can be purchased in 1T bags or in smaller 22kg plastic bags. The smaller plastic bags are sealed and report a longer shelf life up to 12 months. 1T bags will only last several months. It is recommended that an order is placed for a combination of 1T and 22kg bags. This should be coordinated with TEC who will likely require cold mix for upcoming trenching for its new street lights.

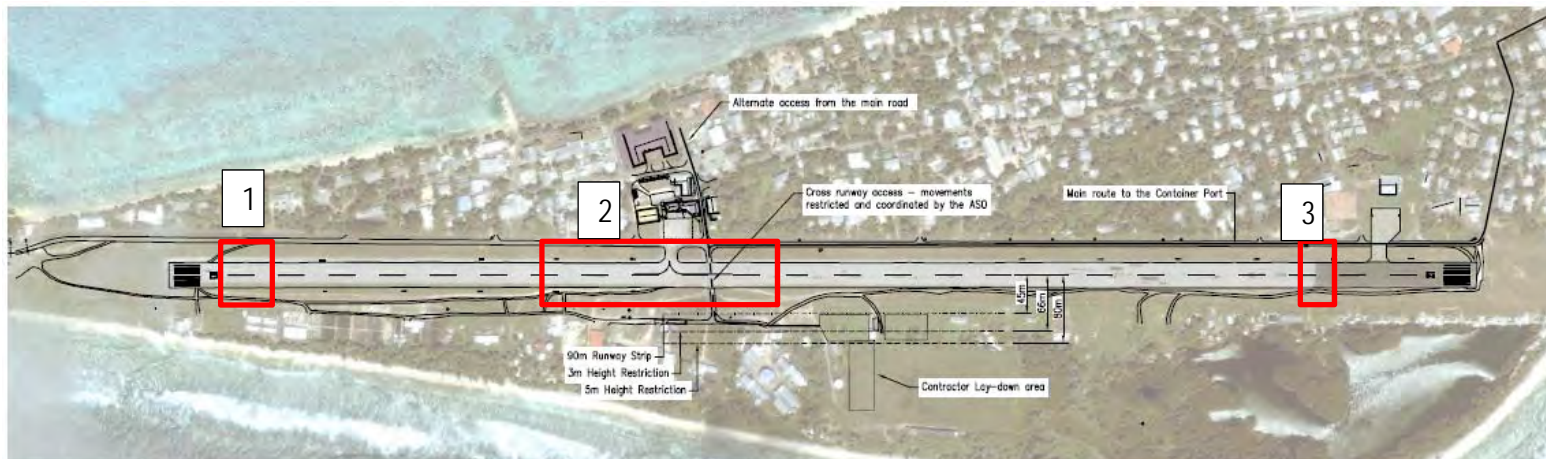
Figure – Indicating the positions for installing Herringbone drainage system

- Runway dimensions for affected areas:
 1. 100m x 30m
 2. 350m x 30m
 3. 50 m x 30m

The preferred option would be to install sub-surface fish bone type drainage system using a directional drilling technique. That way the current base course and surface does not have to be replaced. However, the final option will depend on engineering assessment of the integrity of the current base course.

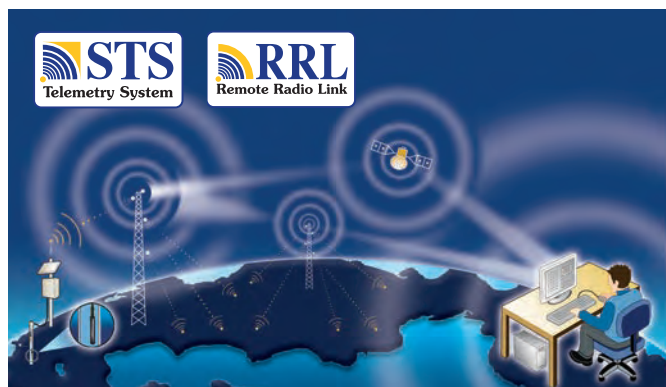
The STS Telemetry System provides an economical and efficient method to send Levellogger data from the field to your desktop. Built for Levelloggers, the system combines high quality dataloggers, intuitive software, and wireless communication, to create a remote monitoring solution.

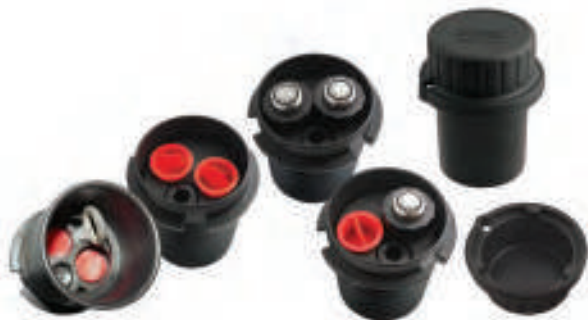
The well cap has a convenient eyelet for suspending Levelloggers using wireline or Kevlar cord. The Well Cap insert has two openings to accommodate Direct Read Cables for both a Levellogger and Barologger. Adaptors are available to fit 4" wells.

The cap is vented to equalize atmospheric pressure in the well. It slips over the casing, and the cap can be secured using a lock with a 3/8" (9.5 mm) shackle diameter.

*Levellogger 2" Locking Well Cap Installations
(see Well Caps data sheet for more details)*

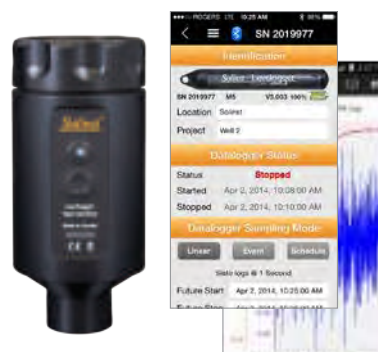
Solinst Levelogger App & Levelogger App Interface

The Levelogger App Interface uses Bluetooth® technology to connect your Levelogger to your smart device. With the Solinst Levelogger App, you can download data, view real-time data, and program your Leveloggers. Data can be e-mailed from your smart device directly to your office (see Model 3001 Levelogger App & Interface data sheets).

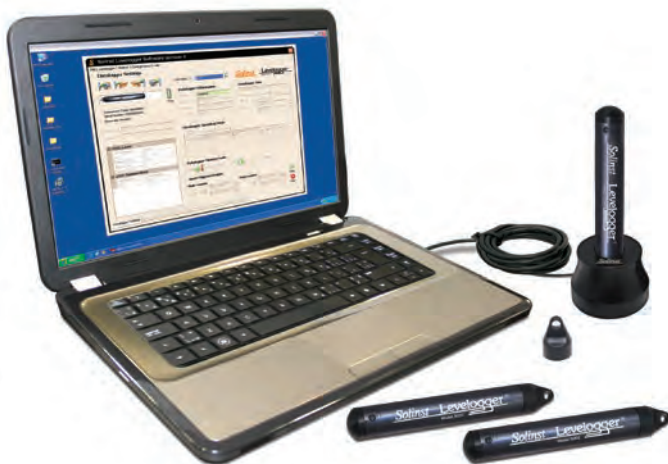
Fast communication and downloading speeds with a high speed Optical Reader
